27. SECURITY DOORS AND WINDOWS

28. SHUTTERS

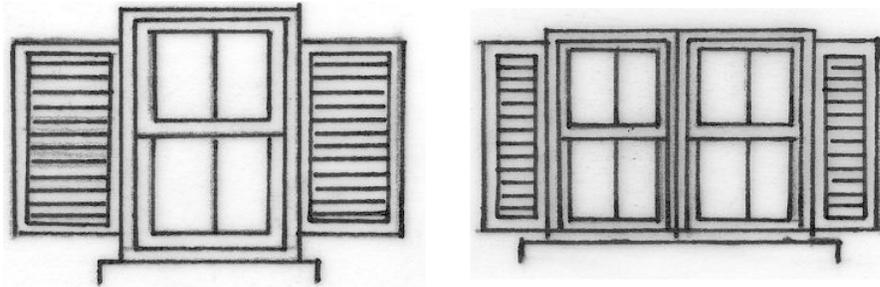
Inappropriate Shutters – would not fit windows if closed

- A. should not be added unless the building originally had them, the shutters are of louvered construction or another historical style, and the shutters will fit the window opening (so that if closed, they would cover the window opening).
- B. of vinyl construction are not permitted. These shutters generally have exaggerated wood graining, which is not convincing or compatible with historic dwellings.
- C. must be installed with appropriate mounting and closure hardware and installed in the proper plane on the window casing as if operable (note: shutters do not actually have to be operable). Flush mounted wall installations shall not be permitted.

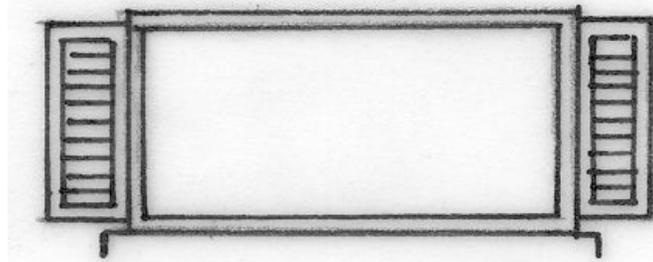
Inappropriate Shutters

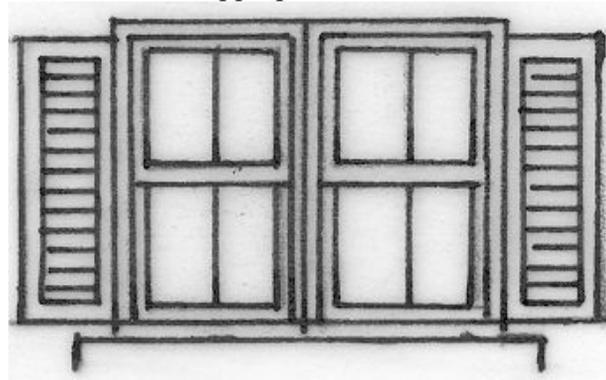
Inappropriate Shutters

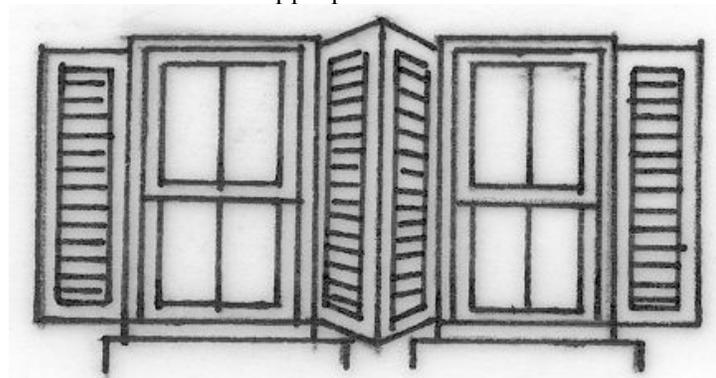
Appropriate Shutters would cover windows when closed
