119 Coolidge Avenue – Contributing

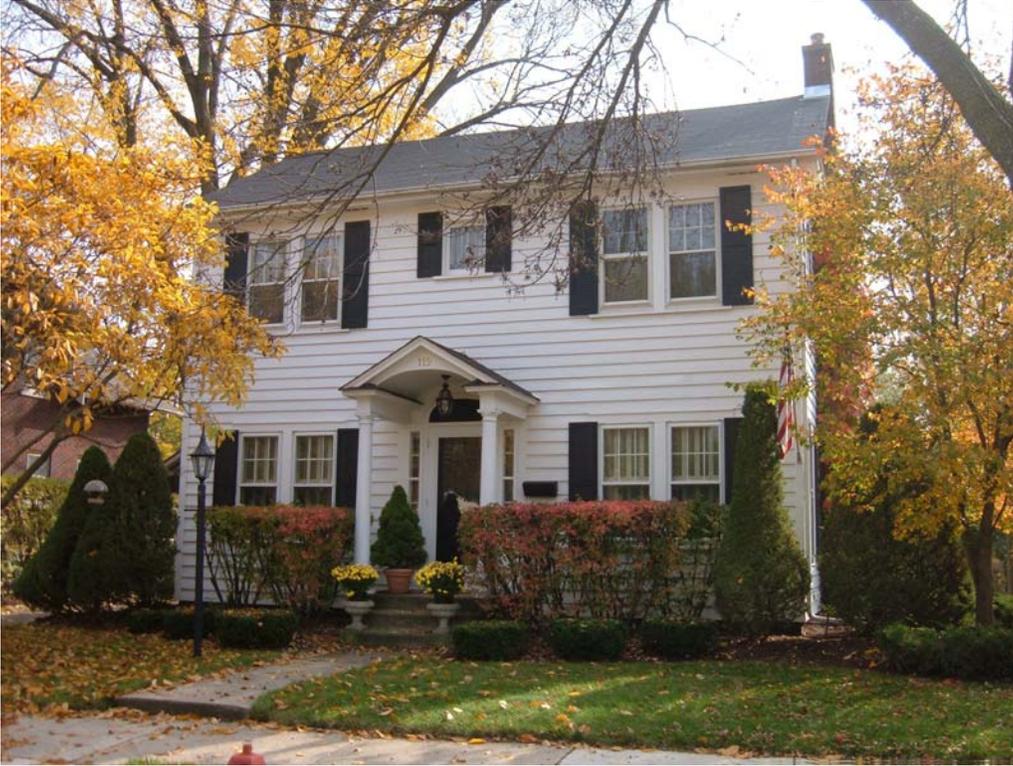
This is a two-story side-gabled Colonial Revival style dwelling built ca. 1920. The house has an exterior of weatherboard siding, a roof of asphalt shingles with gable returns, an exterior brick chimney and a continuous brick foundation. On the main (N) façade is a centrally sited entrance beneath a gable roof entry porch supported by Tuscan columns with an arched ceiling. The main entrance retains its original, four-light and four-wood panel door with original four-light glass and wood sidelights above which is an original wood sunburst panel. Windows are original, six-over-one double hung wood sash. Centrally located on the upper façade is a square, multi-light Craftsman-style leaded glass window.

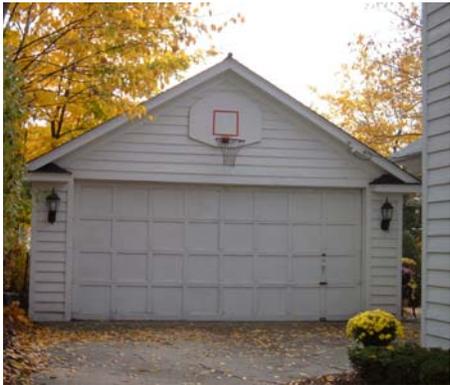
Located to the rear of the dwelling is a ca. 1930, one-bay, frame garage with a gable roof of asphalt shingles with gable returns, an exterior of weatherboard siding and a ca. 1950, thirty-two wood panel overhead track door.
Contributing
