## 118 E. Hillside Avenue – Contributing

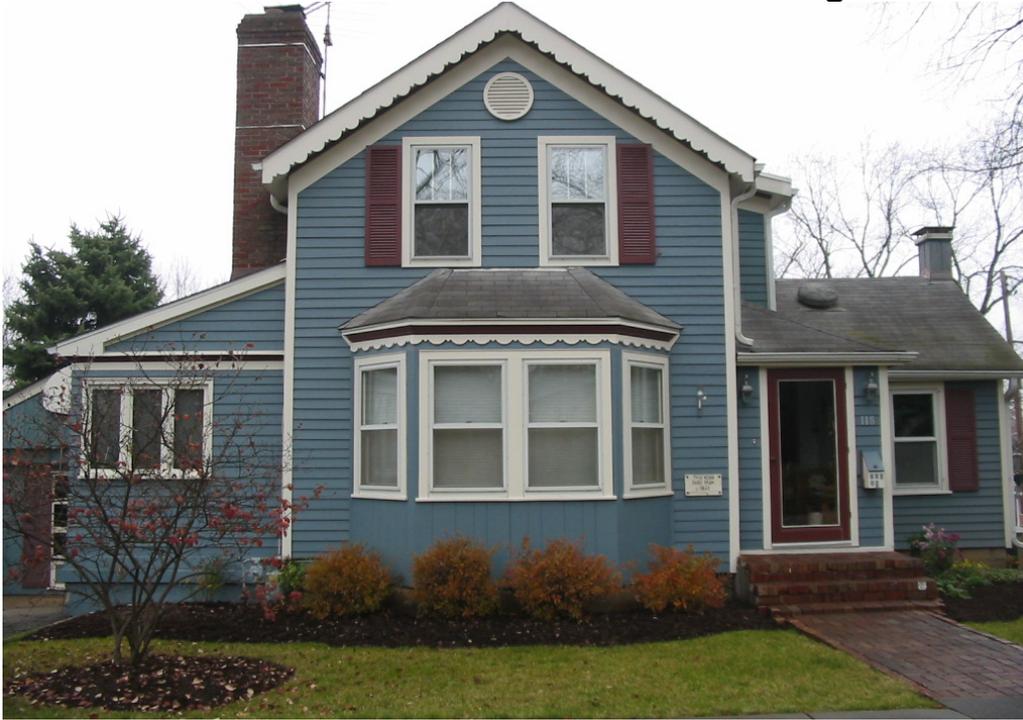
At this location is a ca. 1869 house, according to the sign on the outside, however there is no indication of that date, as the house was extensively remodeled ca. 1990.

The house is a two-story, frame, gable front dwelling with an asphalt shingle roof, a concrete block and poured concrete foundation, a newly built or rebuilt brick chimney and an exterior of new weatherboard siding. A small shed roof lateral addition has been added to the west elevation and has a large picture window and single-light fixed windows. A recently constructed garage is to the west of the dwelling and appears to be attached. The main façade has an added bay window and ca. 1990, one-over-one double hung vinyl sash and original, three-over-one vertical-light double hung wood sash windows. A small entry bay has been added to the main and east façade with a ca. 1990, glass and wood door. Large shed roof and gable roof extensions have been added to the east elevation. This elevation also has a newly constructed wood deck. The garage, if considered a separate structure, is **Non-contributing**.
